# **Eco-Teens**

## **TALBOT-NORFOLK TRIANGLE**

# **Walk Audit Report**

**August 2015**

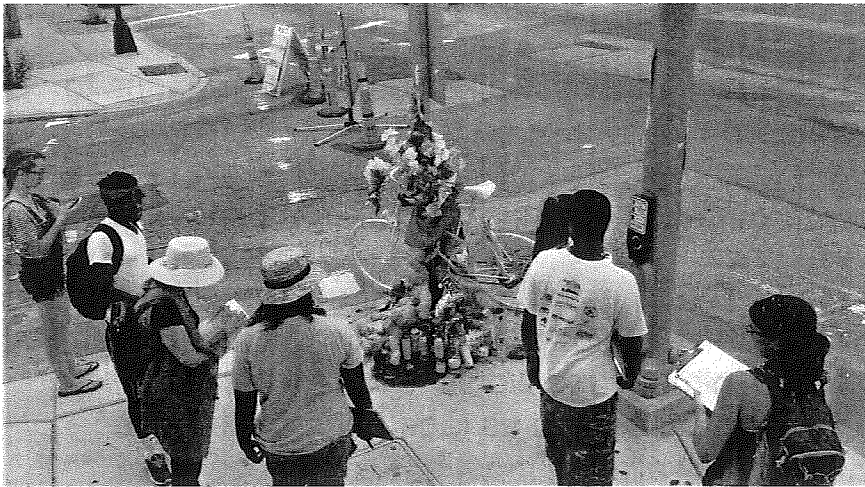
### **Eco-Teens Assessing Talbot-New England Ave Intersection Site of Bicycle Fatality**

Also note faded crosswalks. Pedestrians need more WALK time to cross Talbot.

- Better crossing conditions, at least 20 seconds to cross with the WALK at Talbot and New England Avenue.
- Trash bins

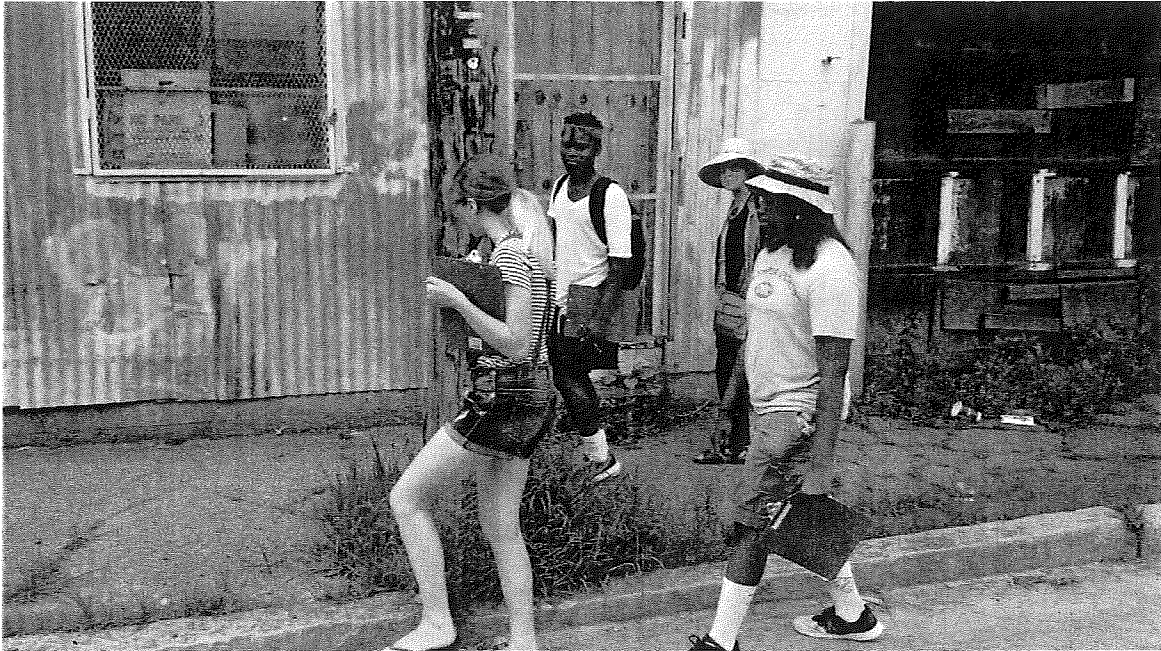
**Eco Teens survey the overgrown sidewalks on New England Ave.**

**On New England Ave.**, the sidewalks are broken to the point that it is a safety issue. There are also no public trashcans and that has resulted in New England Ave. being covered in garbage. See photo below. It would be extremely helpful to get public trashcans on New England Ave. now and to have the sidewalks repaired.

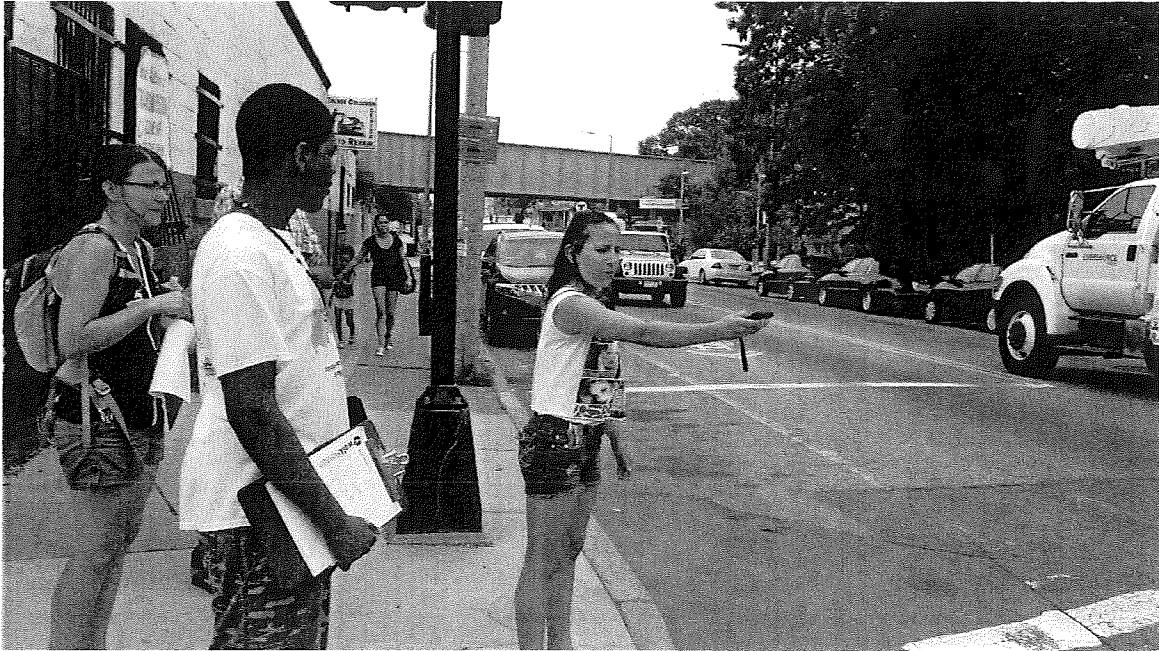
**Eco-Teen Measures Traffic Speeds on Talbot Ave.**  
Speeds on Talbot ranged from 20 – 40 mph.
